IDOC 0148-16R8

King Air Fusion Technical Topics

This Info Doc is intended to be a repository of technical topics, tips, and discussion regarding the operation of the Fusion system as installed on Textron King Air aircraft. This Information Document (IDOC) will be continuously updated as new questions or troubleshooting guidelines become available; new topics will be added to this Information Document, or as applicable, new information will supersede the previous information on existing topics.

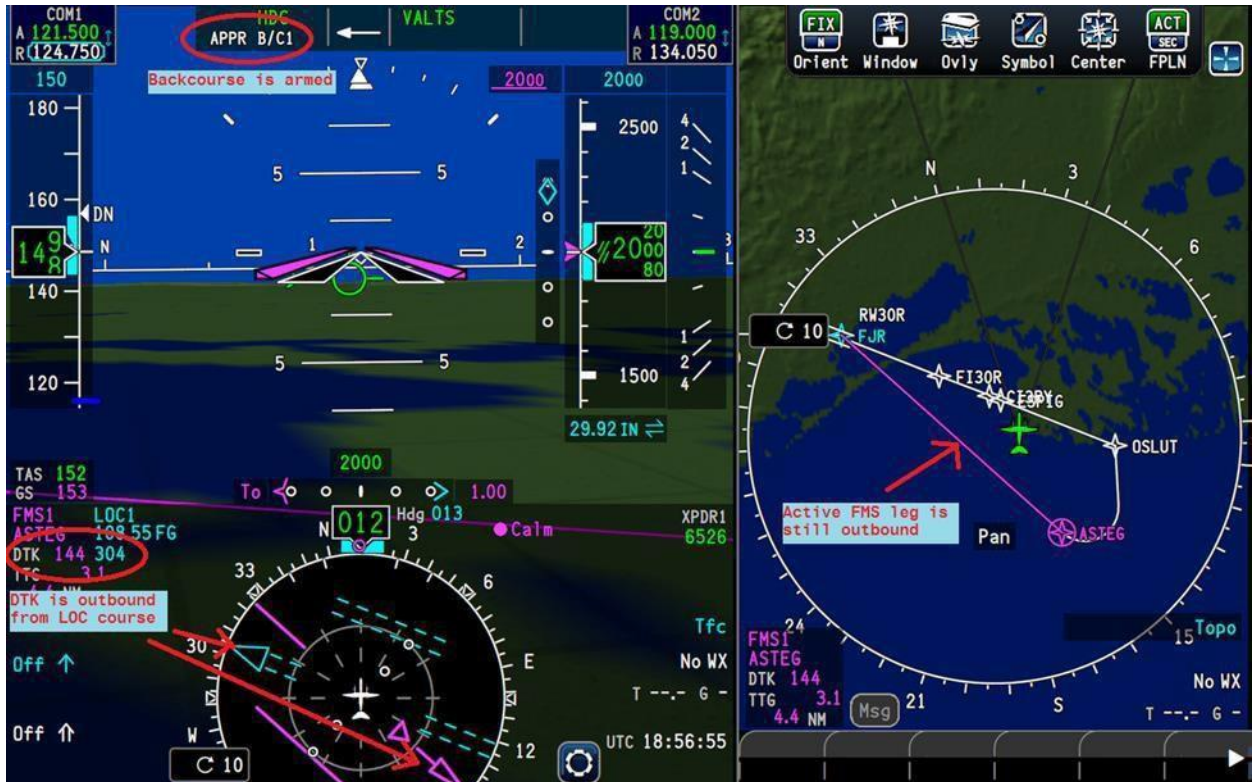
Rockwell Collins recommends that pilots always “clean up” the approach prior to the NAV-to-NAV transition. If the FMS flight plan guidance is to fly outbound and then turn back around for the localizer intercept, and instead vectors are given to shortcut the flight plan, the system may arm the back course approach when the front course is expected. This happens when the aircraft does not fly far enough outbound to satisfy the FMS logic to sequence through the flight plan legs prior to the inbound portion of the approach. When this happens, the FMS flight plan should be cleaned up so that the TO leg is along the final approach course. Failure to do so will leave the FMS Desired Track (DTK) in the active NAV source as an outbound heading. Then, when turning inbound in HDG mode and arming the approach, the automatic back course selection logic looks at the difference between the final approach course and the active navigation source DTK, and arms the back course instead of the localizer front course. When the capture happens, the current aircraft heading is used and the localizer front course is selected.

It should be noted that this is a change in logic from Pro Line 21 equipped aircraft where the localizer course was always used as a reference, even if the active navigation source is FMS. An example of this situation is depicted on the following page (Figures 2 and 3.)

Figure 2. FMS outbound active leg with approach armed.

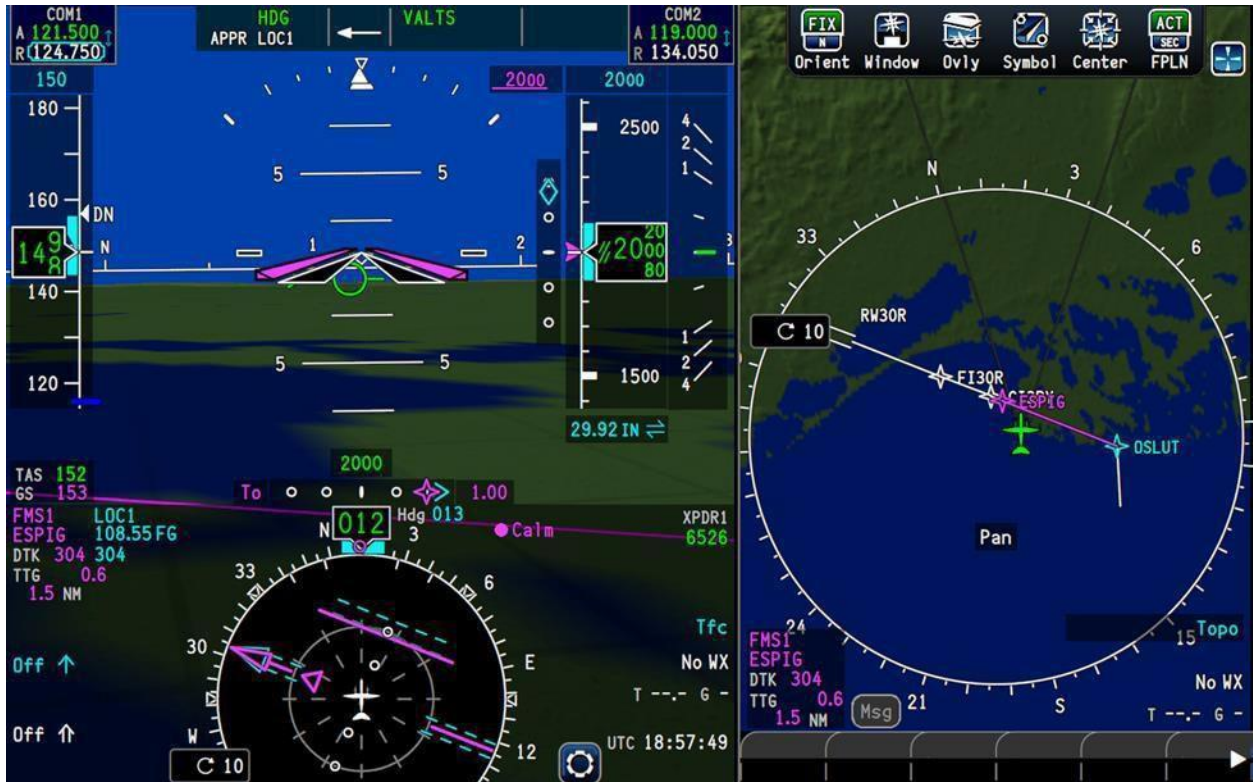
Figure 3. Approach armed after FMS flight plan is cleaned up to inbound course.

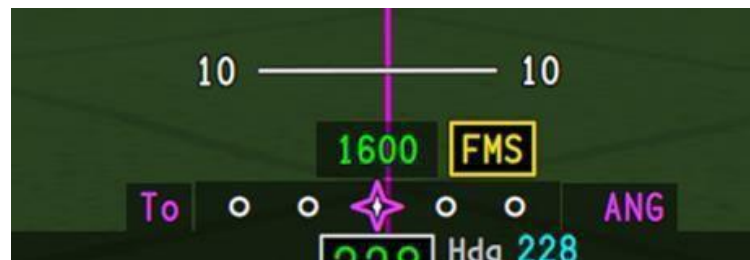
a.) There have been 21 LPV approaches identified where the Rockwell Collins Fusion system will annunciate an FMS Comparator Failure (Figure 4) after sequencing the FAF. This is due to a conservative logic error in the LPV monitor code in the display software. If an LPV comparator annunciation is displayed during an approach, flight crews must still initiate a missed approach procedure.

Figure 4. FMS Comparator Failure Message.

Rockwell Collins recommends selecting a different approach to the runway if available, or electing to fly the approach using Baro VNAV instead of LPV and flying to the LNAV/VNAV line of minima on the chart. To change to Baro VNAV, open the Arrivals Dialog Box to select the approach (Figure 5.) Once the approach is selected, the status line will display the service provider (e.g. WAAS, EGNOS, etc.) and the level of service; in this case, LPV.

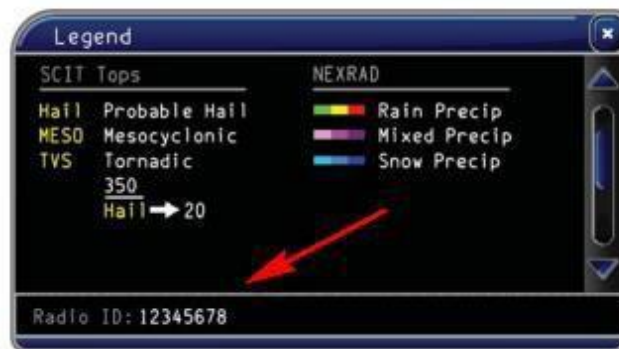
The Radio ID on the Legends Menu may show up as dashes. It does not mean that the XMWR-1000 is not functioning.

If the Radio ID is dashed and needed for a subscription Renewal/Rehit the Radio ID can be found on a sticker affixed to the XMWR-1000 chassis opposite the connectors and will be in the format of:
