**OPSB 0166-17R1**

**Date:** October 23, 2017

**Subject:** The FMS may turn in the wrong direction after sequencing a "Climb to" altitude that was manually edited or Temperature Compensated

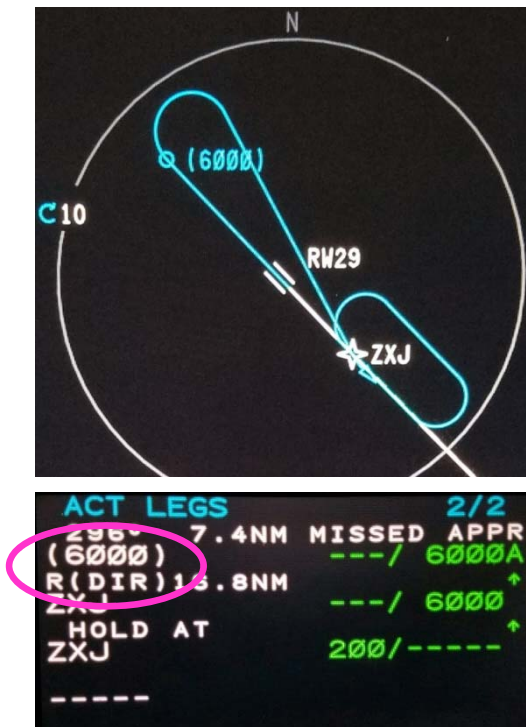
Figures 2a and 2b show the issue for the CYXJ (Ft. St. John, BC) ILS Rwy 29 missed approach. In Figure 2a, on the LEGS page,

- **“Climb to” altitude of 6000 feet** is identified by the parentheses: “(6000)”
- **Turn direction is right**, identified by “R” (Right) for the immediately following leg

Figure 2a. "Climb to 6000 feet followed immediate by Right turn Direct-to ZXJ.

1. If Temperature Compensation is ON, turn Temperature Compensation OFF, and press EXEC.
2. Reselect the procedure (departure or approach), and press EXEC.
3. Do not again manually edit the "Climb to" altitude, and do not re-activate Temperature Compensation.

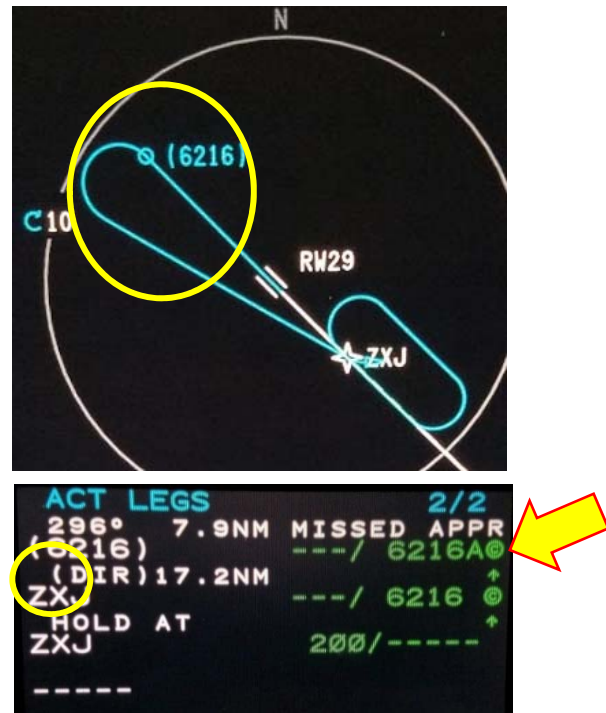
Figure 2b shows that after the crew activates Temperature Compensation, the turn direction is removed, initially on the “non-edit-side FMS” in a dual/triple FMS installation. In other words, if the pilot-not-flying (non-coupled side) makes the edit, the turn direction is initially removed on the pilot-flying (coupled) side. After the active TO waypoint sequences, the turn direction will be removed on both FMSs.

Figure 2b. After the crew uses the left FMS to activate Temperature Compensation, the "R" turn to ZXJ is initially removed (blacked) on the right FMS and will subsequently be removed on both FMSs. The map display may differ from this example.

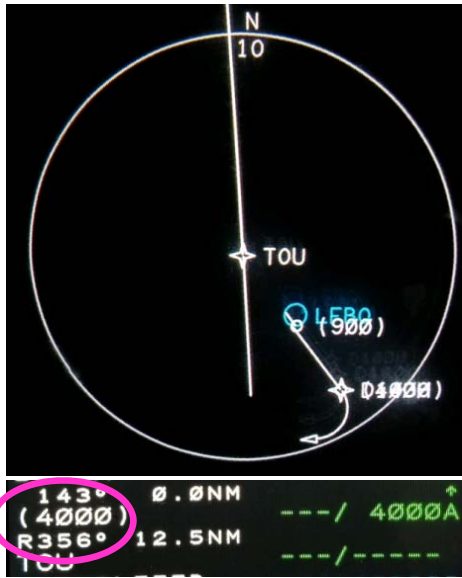
A manual altitude entry immediately removes turn direction on all active FMSs. Figures 3a and 3b show the issue departing LFBO Runway 14L on FIST5A. In Figure 3a, on the LEGS page,

- "Climb to" altitude of 4000 feet is identified by the parentheses: "(4000)"
- Turn direction is right, identified by "R" (Right) for the immediately following leg
- Figure 3b shows that after the crew enters 4200A in place of 4000A as the "Climb to" altitude The "R" (right) turn direction is removed, as shown on the LEGS page
- The shortest turn is currently computed to be left (instead of right), as shown on the map

Figure 3a. "Climb to 4000 feet followed immediate by Right turn 356° course to TOU.

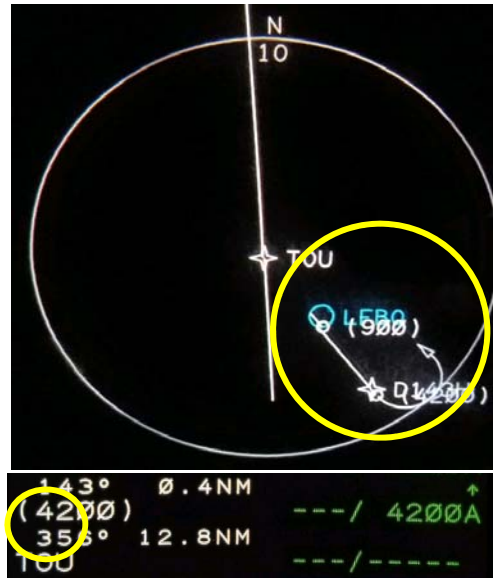
Figure 3b. After manually entering 4200A (in places of 4000A), the "R" turn direction is removed and the FMS computes the shortest turn direction, left in this case.
