OPSB 0166-17R1

Date: October 23, 2017

To: Operators of Rockwell Collins Flight Management Systems Pro Line 4 and Pro Line 21 FMS 3.3.x through FMS 4.x

Subject: The FMS may turn in the wrong direction after sequencing a "Climb to" altitude that was manually edited or Temperature Compensated

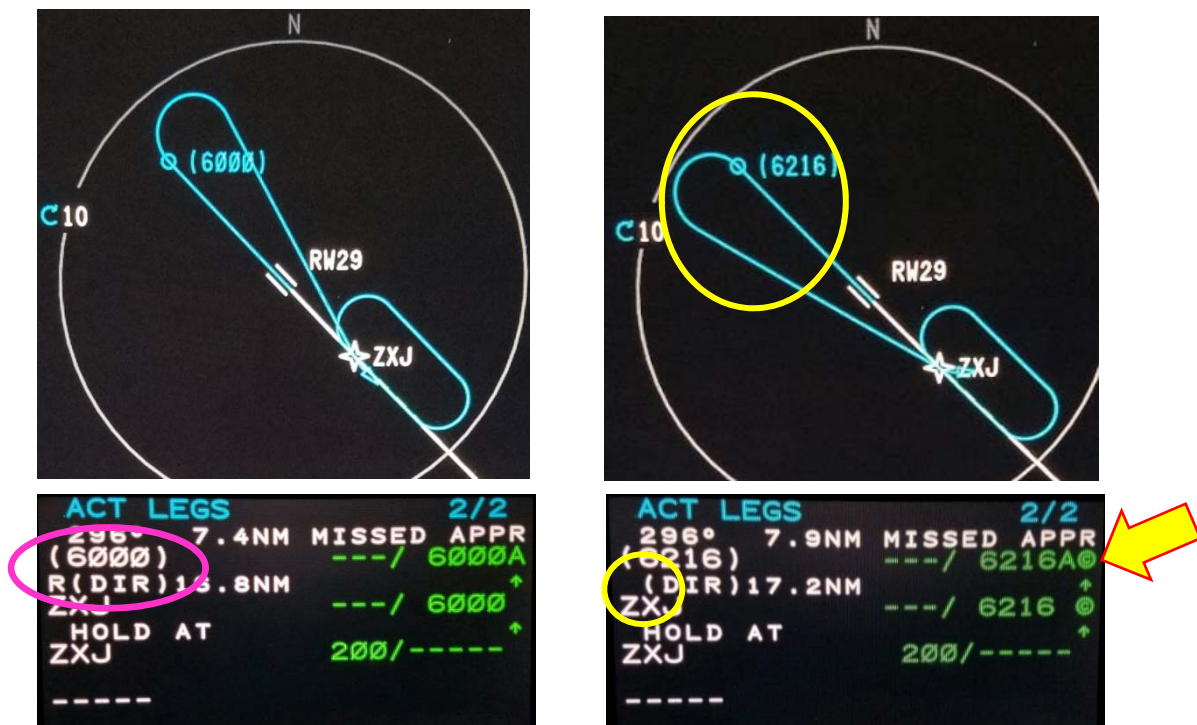
Figures 2a and 2b show the issue for the CYXJ (Ft. St. John, BC) ILS Rwy 29 missed approach. In Figure 2a, on the LEGS page,

- **“Climb to” altitude of 6000 feet** is identified by the parentheses: “(6000)”
- **Turn direction is right**, identified by “R” (Right) for the immediately following leg

Figure 2b shows that after the crew activates Temperature Compensation, the turn direction is removed, initially on the “non-edit-side FMS” in a dual/triple FMS installation. In other words, if the pilot-not-flying (non-coupled side) makes the edit, the turn direction is initially removed on the pilot-flying (coupled) side. After the active TO waypoint sequences, the turn direction will be removed on both FMSs.

Figure 2a. “Climb to 6000 feet followed immediate by Right turn Direct-to ZXJ.

Figure 2b. After the crew uses the left FMS to activate Temperature Compensation, the “R” turn to ZXJ is initially removed (blanked) on the right FMS and will subsequently be removed on both FMSs. The map display may differ from this example.

1. If Temperature Compensation is ON, turn Temperature Compensation OFF, and press EXEC.
2. Reselect the procedure (departure or approach), and press EXEC.
3. Do not again manually edit the "Climb to" altitude, and do not re-activate Temperature Compensation.

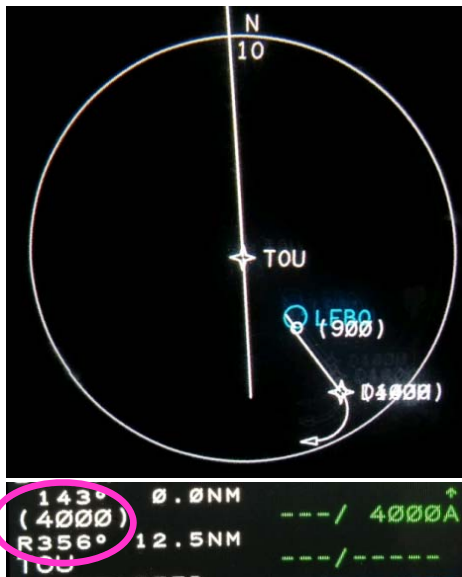
A manual altitude entry immediately removes turn direction on all active FMSs. Figures 3a and 3b show the issue departing LFBO Runway 14L on FIST5A. In Figure 3a, on the LEGS page,

- **“Climb to” altitude of 4000 feet** is identified by the parentheses: “(4000)”
- **Turn direction is right**, identified by “R” (Right) for the immediately following leg
 - Figure 3b shows that after the crew enters 4200A in place of 4000A as the “Climb to” altitude The “R” (right) turn direction is removed, as shown on the LEGS page
 - The shortest turn is currently computed to be left (instead of right), as shown on the map

Figure 3a. "Climb to 4000 feet followed immediate by Right turn 356° course to TOU.

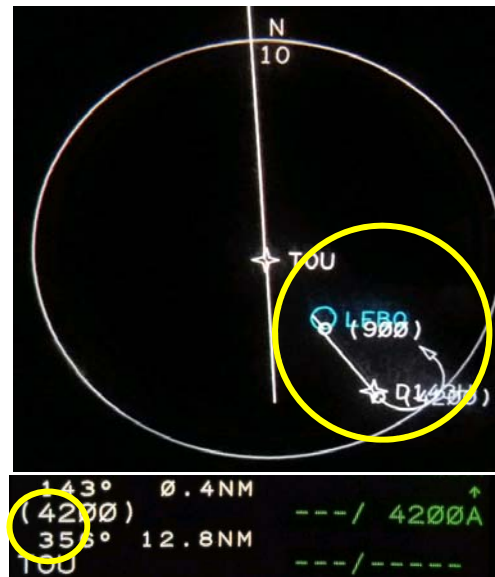
Figure 3b. After manually entering 4200A (in places of 4000A), the "R" turn direction is removed and the FMS computes the shortest turn direction, left in this case.
