**Rockwell
Collins**

OPSB 0166-17R4

Subject: The FMS may turn in the wrong direction after sequencing a “Climb to” altitude that was manually edited or Temperature Compensated

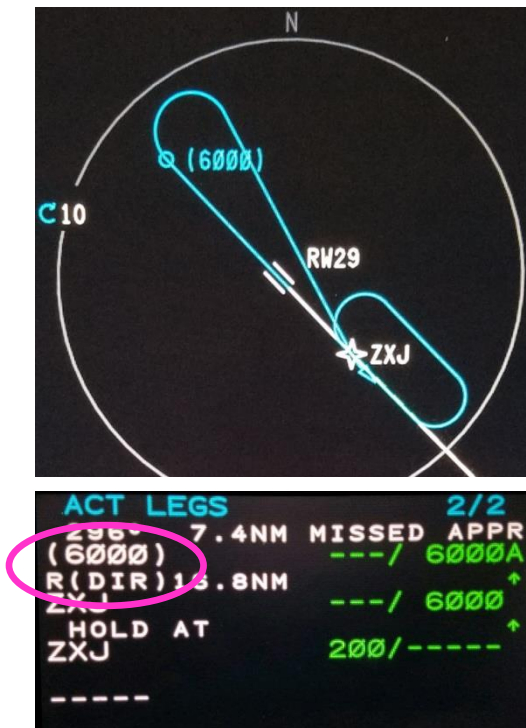
Figures 2a and 2b show the issue for the CYXJ (Ft. St. John, BC) ILS Rwy 29 missed approach. In Figure 2a, on the LEGS page,

- **“Climb to” altitude of 6000 feet** is identified by the parentheses: **“(6000)”**
- **Turn direction is right**, identified by **“R”** (Right) for the immediately following leg

Figure 2a. “Climb to 6000 feet followed immediate by Right turn Direct-to ZXJ.

1. If Temperature Compensation is ON, turn Temperature Compensation OFF, and press EXEC.
2. Reselect the procedure (departure or approach), and press EXEC.
3. Do not again manually edit the “Climb to” altitude, and do not re-activate Temperature Compensation.

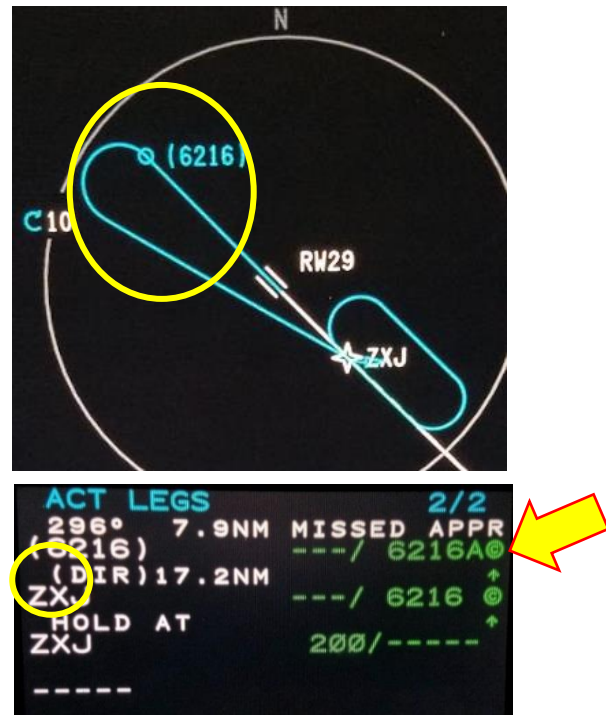
Figure 2b shows that after the crew activates Temperature Compensation, the turn direction is removed, initially on the “non-edit-side FMS” in a dual/triple FMS installation. In other words, if the pilot-not-flying (non-coupled side) makes the edit, the turn direction is initially removed on the pilot-flying (coupled) side. After the active TO waypoint sequences, the turn direction will be removed on both FMSs.

Figure 2b. After the crew uses the left FMS to activate Temperature Compensation, the “R” turn to ZXJ is initially removed (blacked) on the right FMS and will subsequently be removed on both FMSs. The map display may differ from this example.
