**OPSB 0166-17R4**

Date: December 13, 2017

To: Operators of Rockwell Collins Flight Management Systems Pro Line 4 and Pro Line 21 FMS 3.3.x through FMS 4.x

Subject: The FMS may turn in the wrong direction after sequencing a “Climb to” altitude that was manually edited or Temperature Compensated

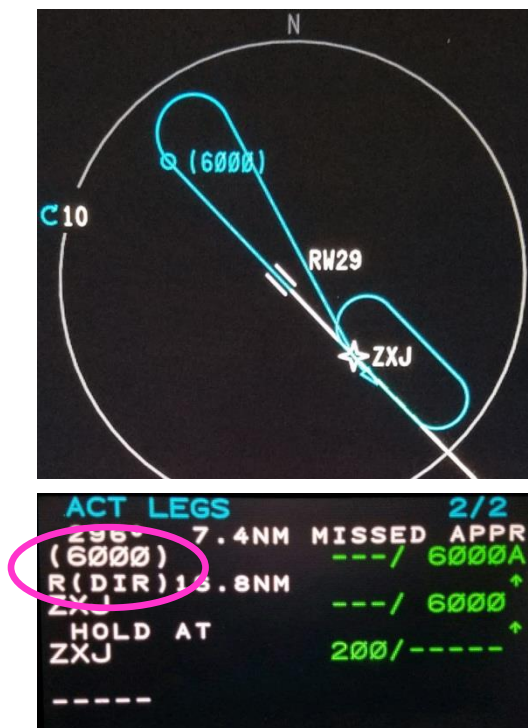
Figures 2a and 2b show the issue for the CYXJ (Ft. St. John, BC) ILS Rwy 29 missed approach. In Figure 2a, on the LEGS page,

- **“Climb to” altitude of 6000 feet** is identified by the parentheses: **“(6000)”**
- **Turn direction is right**, identified by **“R”** (Right) for the immediately following leg

Figure 2a. “Climb to 6000 feet followed immediate by Right turn Direct-to ZXJ.

1. If Temperature Compensation is ON, turn Temperature Compensation OFF, and press EXEC.
2. Reselect the procedure (departure or approach), and press EXEC.
3. Do not again manually edit the “Climb to” altitude, and do not re-activate Temperature Compensation.

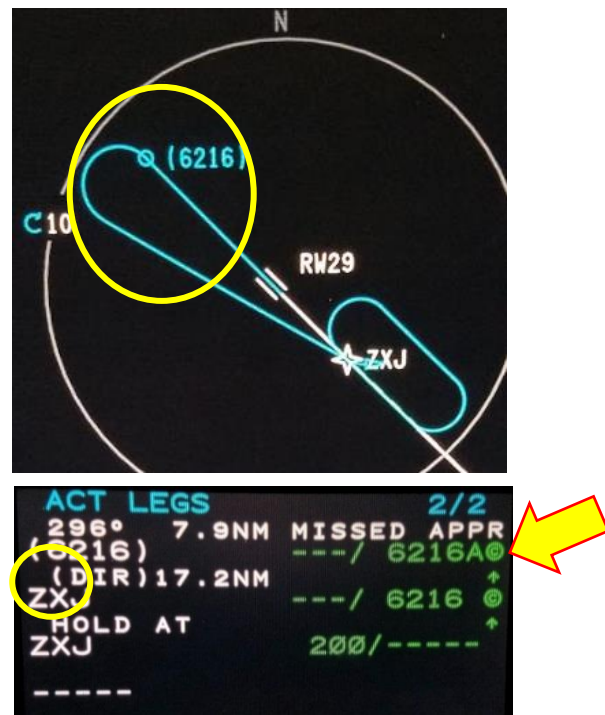
Figure 2b shows that after the crew activates Temperature Compensation, the turn direction is removed, initially on the “non-edit-side FMS” in a dual/triple FMS installation. In other words, if the pilot-not-flying (non-coupled side) makes the edit, the turn direction is initially removed on the pilot-flying (coupled) side. After the active TO waypoint sequences, the turn direction will be removed on both FMSs.

Figure 2b. After the crew uses the left FMS to activate Temperature Compensation, the “R” turn to ZXJ is initially removed (blanked) on the right FMS and will subsequently be removed on both FMSs. The map display may differ from this example.
