IDOC 0148-16R8

King Air Fusion Technical Topics

Summary

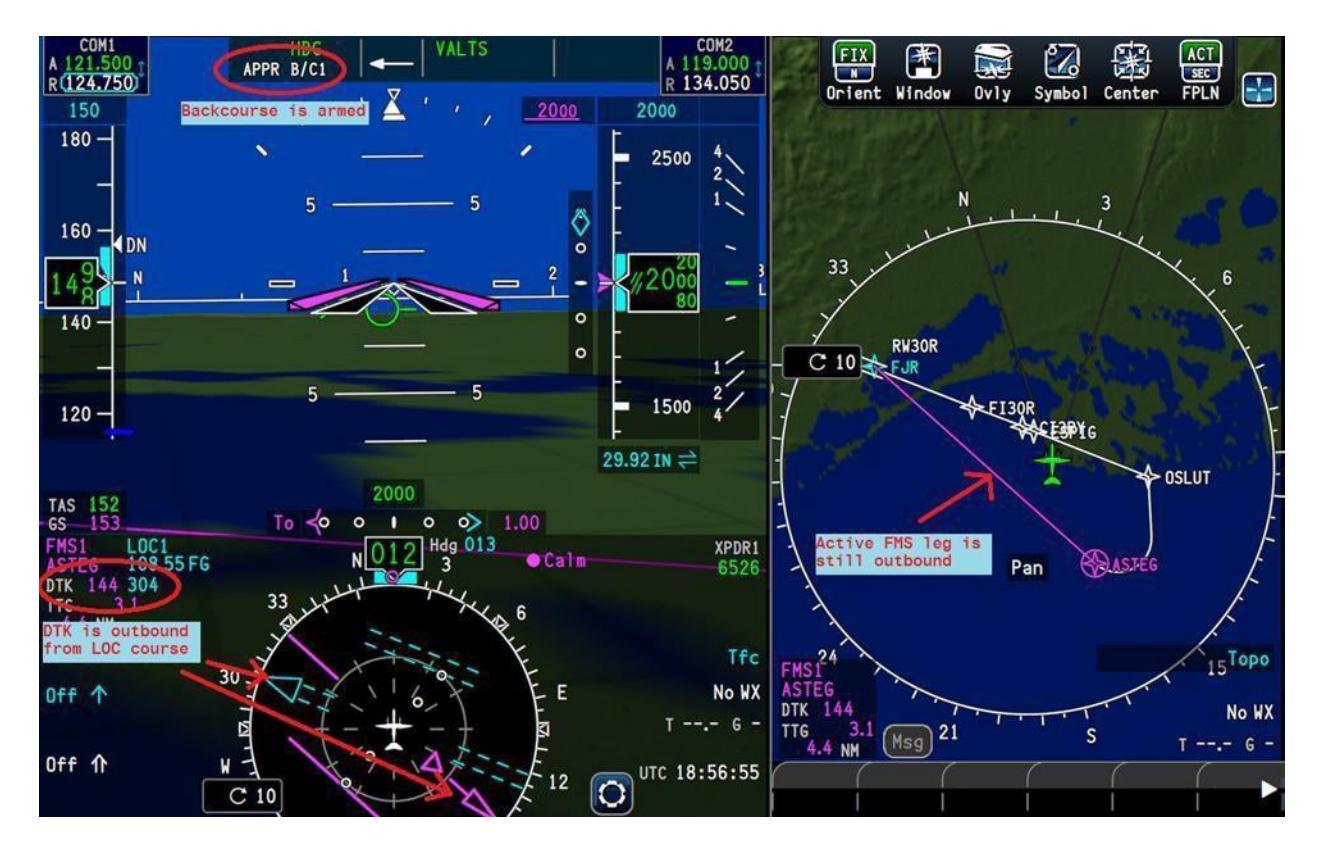
Rockwell Collins recommends that pilots always "clean up" the approach prior to the NAV-to-NAV transition. If the FMS flight plan guidance is to fly outbound and then turn back around for the localizer intercept, and instead vectors are given to shortcut the flight plan, the system may arm the back course approach when the front course is expected. This happens when the aircraft does not fly far enough outbound to satisfy the FMS logic to sequence through the flight plan legs prior to the inbound portion of the approach. When this happens, the FMS flight plan should be cleaned up so that the TO leg is along the final approach course. Failure to do so will leave the FMS Desired Track (DTK) in the active NAV source as an outbound heading. Then, when turning inbound in HDG mode and arming the approach, the automatic back course selection logic looks at the difference between the final approach course. DTK, and arms the back course instead of the localizer front course is selected.

It should be noted that this is a change in logic from Pro Line 21 equipped aircraft where the localizer course was always used as a reference, even if the active navigation source is FMS. An example of this situation is depicted on the following page (Figures 2 and 3.)

Figure 2. FMS outbound active leg with approach armed.

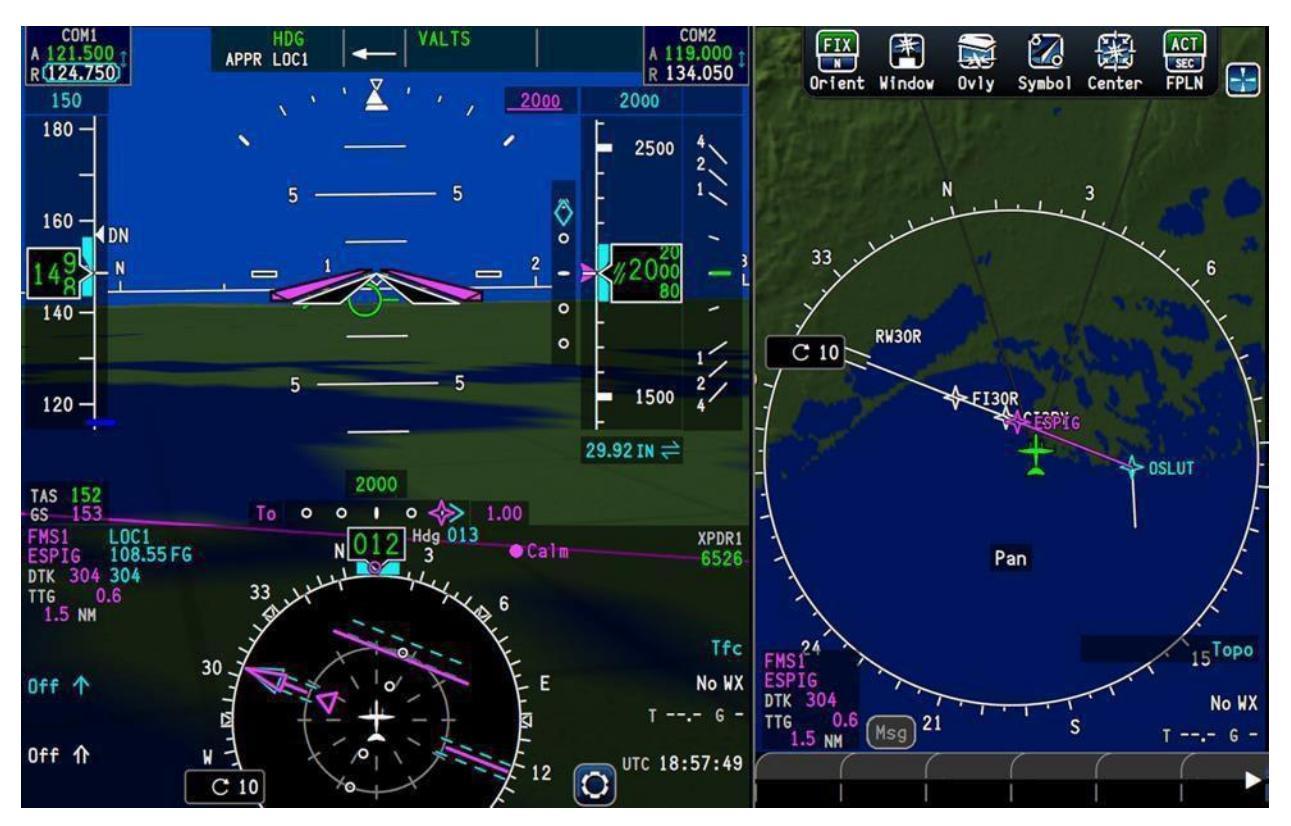
Figure 3. Approach armed after FMS flight plan is cleaned up to inbound course.

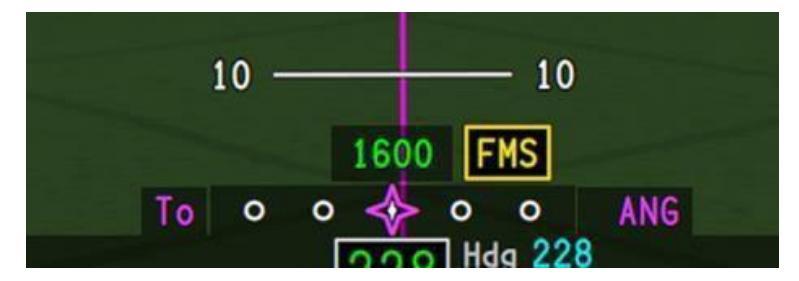
a.) There have been 21 LPV approaches identified where the Rockwell Collins Fusion system will annunciate an FMS Comparator Failure (Figure 4) after sequencing the FAF. This is due to a conservative logic error in the LPV monitor code in the display software. If an LPV comparator annunciation is displayed during an approach, flight crews must still initiate a missed approach procedure.

Figure 4. FMS Comparator Failure Message.

Rockwell Collins recommends selecting a different approach to the runway if available, or electing to fly the approach using Baro VNAV instead of LPV and flying to the LNAV/VNAV line of minima on the chart. To change to Baro VNAV, open the Arrivals Dialog Box to select the approach (Figure 5.) Once the approach is selected, the status line will display the service provider (e.g. WAAS, EGNOS, etc.) and the level of service; in this case, LPV.

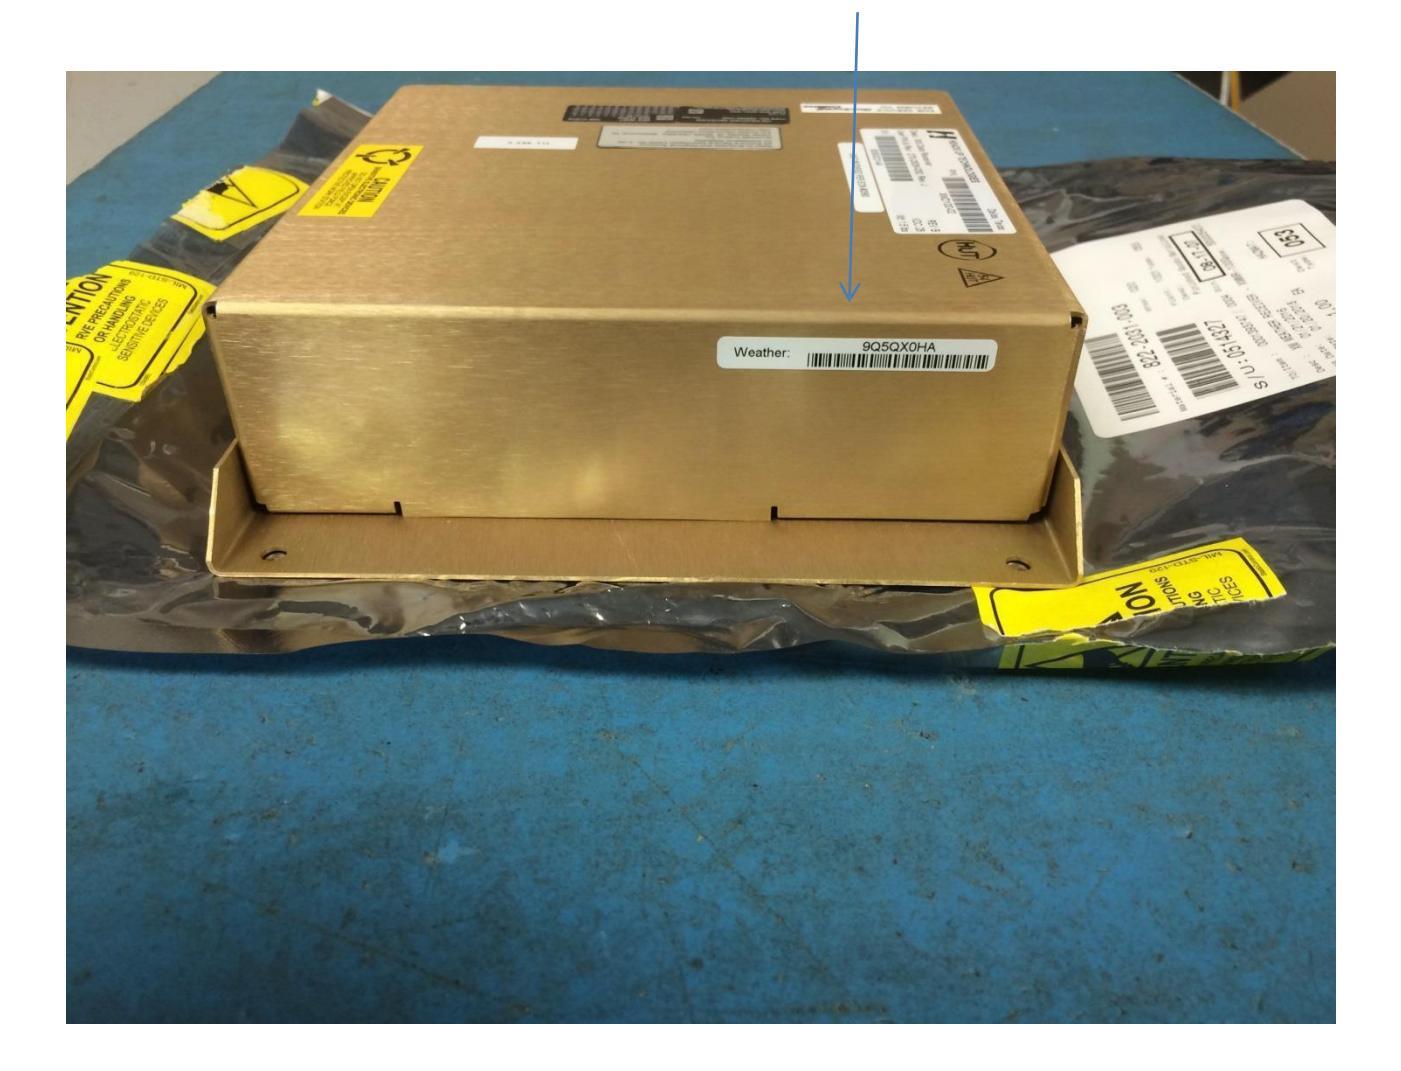
The Radio ID on the Legends Menu may show up as dashes. It does not mean that the XMWR-1000 is not functioning.

(A picture of the Radio ID tag location is shown below)

If the Radio ID is dashed and needed for a subscription Renewal/Rehit the Radio ID can be found on a sticker affixed to the XMWR-1000 chassis opposite the connectors and will be in the format of:
