IDOC 0148-16R8

King Air Fusion Technical Topics

This Info Doc is intended to be a repository of technical topics, tips, and discussion regarding the operation of the Fusion system as installed on Textron King Air aircraft. This Information Document (IDOC) will be continuously updated as new questions or troubleshooting guidelines become available; new topics will be added to this Information Document, or as applicable, new information will supersede the previous information on existing topics.

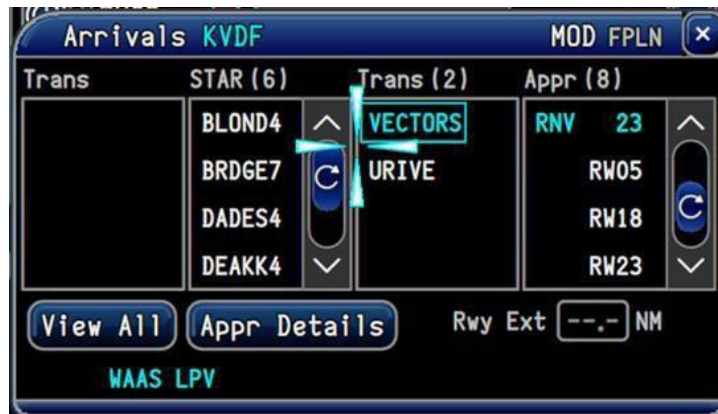
Figure 5. Arrivals Dialog Box.

a.) There have been 21 LPV approaches identified where the Rockwell Collins Fusion system will annunciate an FMS Comparator Failure (Figure 4) after sequencing the FAF. This is due to a conservative logic error in the LPV monitor code in the display software. If an LPV comparator annunciation is displayed during an approach, flight crews must still initiate a missed approach procedure.

Rockwell Collins recommends selecting a different approach to the runway if available, or electing to fly the approach using Baro VNAV instead of LPV and flying to the LNAV/VNAV line of minima on the chart. To change to Baro VNAV, open the Arrivals Dialog Box to select the approach (Figure 5.) Once the approach is selected, the status line will display the service provider (e.g. WAAS, EGNOS, etc.) and the level of service; in this case, LPV.
